Structure Inventory and Appraisal

Bridge ID: SOLDIER-131040	Official SR: 48.7	SD/FO: Not Deficient or Obsolete
FHWA No.: 131040	Unofficial SR: 48.7	SD/FO: Not Deficient or Obsolete

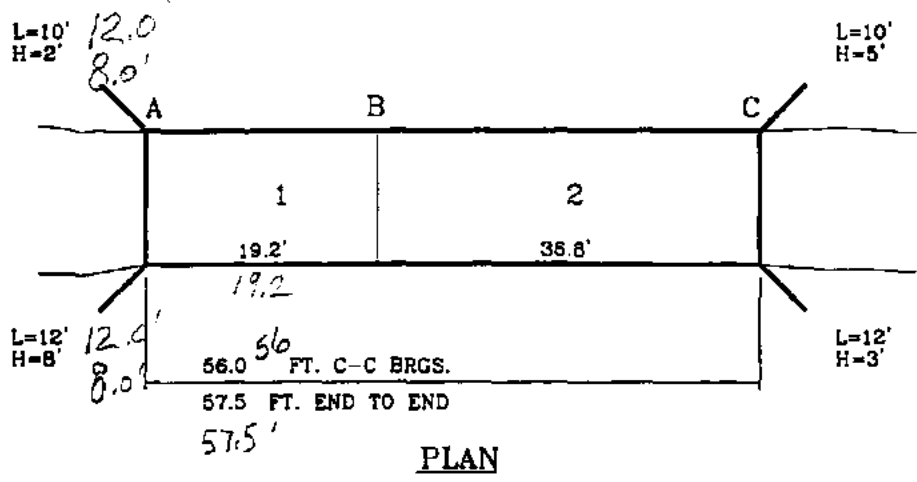
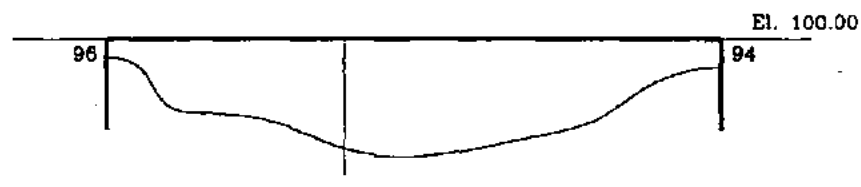
BRIDGE PLAN AND PROFILE

STREAMBED ELEVATION	DATE
82.0	4/10
81.5	4/08
82.0	4/08
81.5	4/04
82.0	1/02
82.0	3/00
82.0	8/99
83.4	12/96

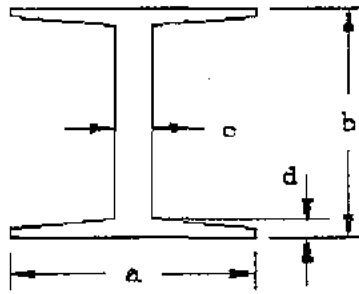
Type AT (Treated)
Type AUT (Untreated)

Type B

Type C

DIMENSIONAL DATA

Span	Length	Element Type	a	b	c	d	Steel beam size	No. beams	Lateral Spacing	Support
1	36.8"	(B)	7"	16"		3/4	S15 x 50#	9	30"	31"

Span	Length	Element Type	a	b	c	d	Steel beam size	No. beams	Lateral Spacing	Support
2	36.8'	B	7"	16"		7/16"	16 x 36#	9	30"

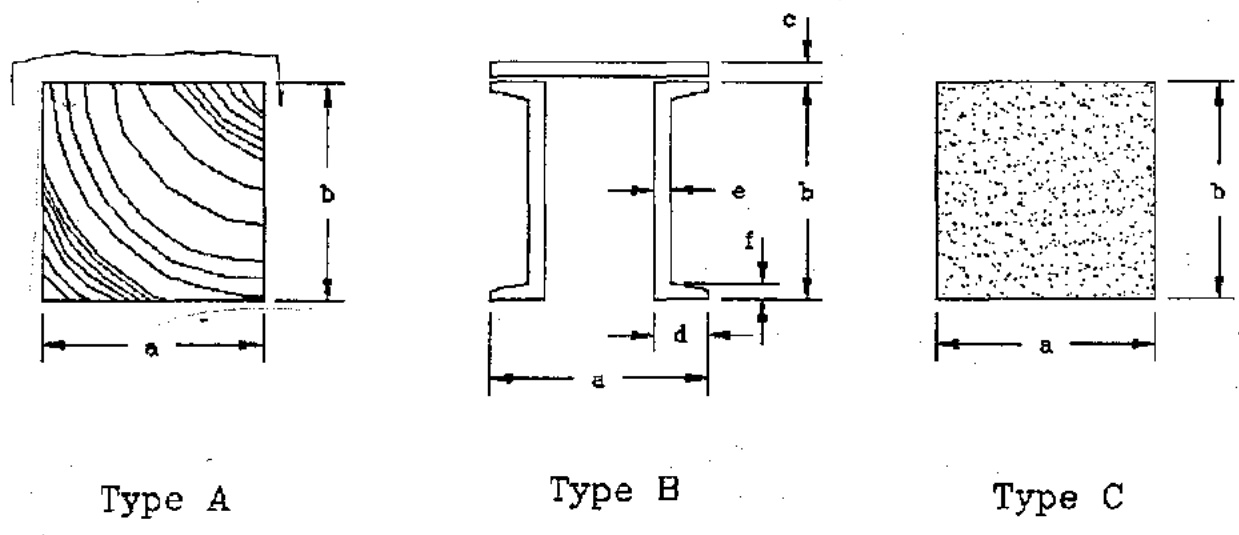
Location	Type	a	b	c	d	e	f
A	A	12"	12"	/	/	/	/
B	B	13"	10"	5/16"	2 3/4"	1/4"	9/16"
C	B	12"	8"	5/16"	2 1/4"	1/4"	1/2"

REMARKS: "A" cap type A with channel on top

PIER/PILE CAPS

Pontis No./Element	Location	Type	Length	Height	Condition		Remarks
					State		
308 timber trestle pile cap	A	A	21.5' 23.5'	1.0' 10' 2"	2		fair condition
244 red lead steel pier cap	B	B	21.5'	0.8'	2		fair cond., moderate rust
238 red lead steel abut. cap	C	B	21.5'	0.7'	2		fair cond., moderate rust
