# UNITED STATES PUBLIC LAND SURVEY CORNER CERTIFICATE

Land Survey Monuments situated in Section 3, Township 83 North, Range 41 West of the Fifth Principal Meridian, Crawford County, Iowa, Previously recorded in (see below) in County Recorder's Office.

These corners were used for a survey in this section for Kragel Farm Corporation. Basis of bearing for this corner certificate can be found on the associated plat of survey filed in the County Recorder's Office for this section.

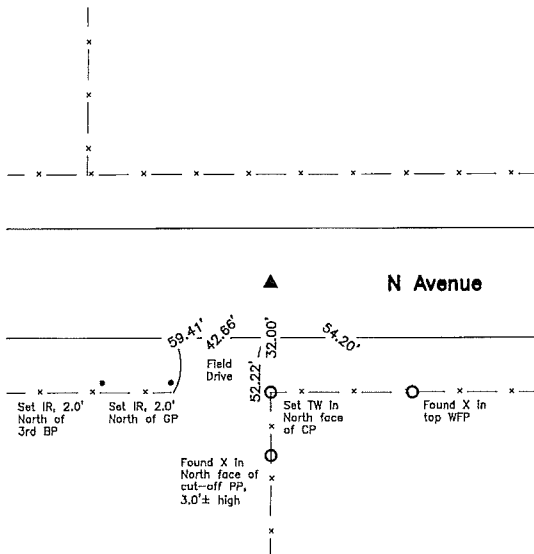
### S¼ Cor.

### County Engineer's Record Ties

History of Corner =  
1882, Apr. 26 - "Govt Cor Set New one Cedar Post & Brick Bats in Mound" per County Engineer's McHenry Field Book 14, Page 54.  
1883, Mar. 15 - County Engineer's McHenry Field Book 35, Pages 13 Indicates usage of corner, but not type of monumentation at corner.

County Engineer's ties indicate that corner is monumented with:

"Found brick bats ½ brick pieces of crockery at road surface Lowered set C.M." on May 13, 1940 with ties as shown above.

Corner Recovery =  
Searched 5.0'± area with metal detector, excavated 1.0'± x 0.6' deep hole and found 4" x 4" brass capped concrete monument, 0.4' deep. Concrete monument is in apparent centerline of traveled surface of gravel road east and dirt road west, in-line with fenceline south, and 56'± east of fenceline north. Location of monument found matches that of record, monument found matches that of record, and record ties are within reason. Therefore, used concrete monument as the correct corner. All ties are plumb distance unless indicated otherwise.
